# Manhole Inspection Summary

Manhole # S19Y\_\_020MH

Insp Date: **6/2/08 10:02 AM**

**Location** Address: **2021 griffis av**

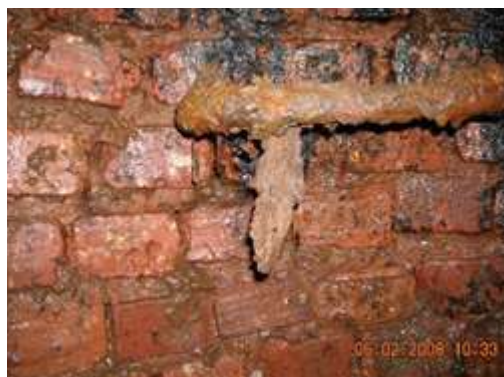
Defect 6

**Steps** Count: **7** Missing: **0** ☒ **Corroded**

corroded steps

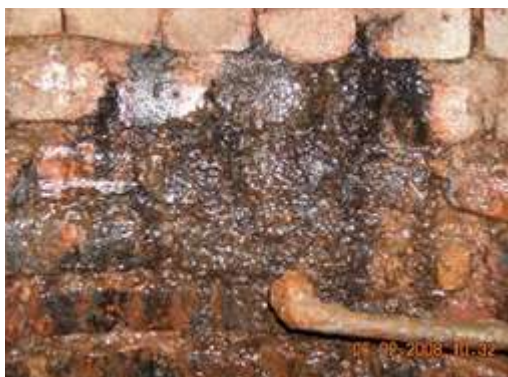
Defect 5

Infiltration: ☐ None ☐ Joint ☐ Cracks ☐ Mortar ☐ Roots ☒ **Wall**

infiltration @ barrel wall

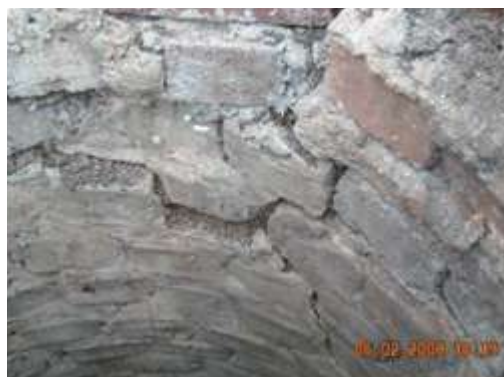
Defect 4

Condition: ☐ Sound ☒ **Cracked** ☐ Root Intrusion ☐ Loose Brick ☐ Deteriorated

cracked corbel bricks

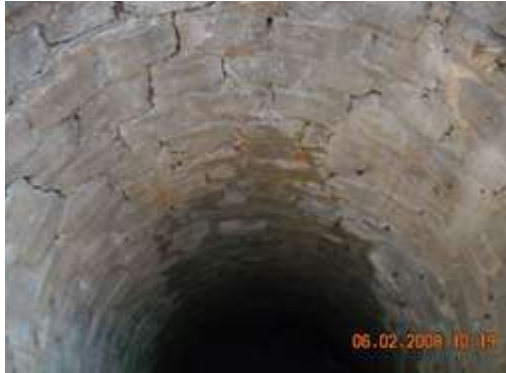
Defect 3

Infiltration: ☐ None ☐ Joint ☐ Cracks ☐ Mortar ☐ Roots ☒ **Wall**

infiltration @ corbel wall

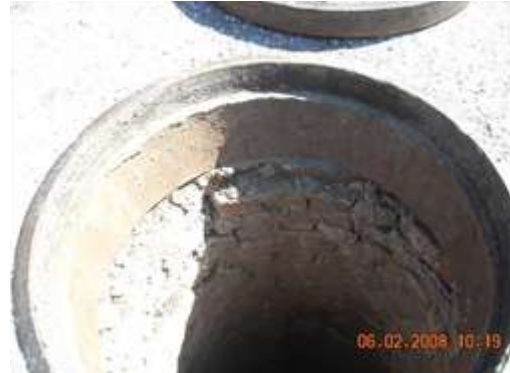
Defect 2

inflow evidence from sheeting

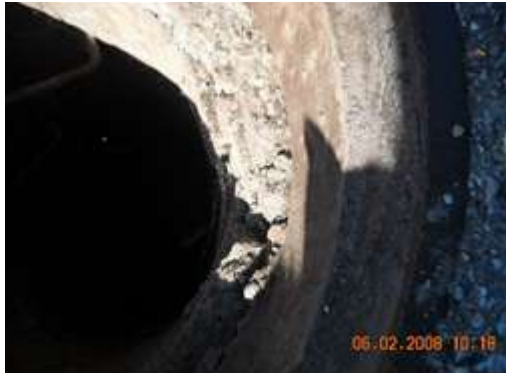
Defect 1

**Frame** Offset: **2** (in.) Condition: ☐ Sound ☐ Cracked ☒ **Leaks**

frame offset

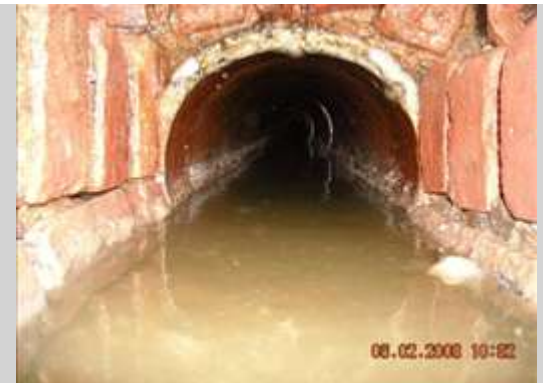
6 O'Clock Inflow

Pipe Height: **8.4** (in.) Rod and Bar (Angled)  
Pipe Material: **Clay** ☐ Pipe Lined  
Invert Depth: **12.86** (ft.) Flow Characteristics: **Slow**  
Deposits: ☒ None ☐ Mud ☐ Sludge ☐ Debris ☐ Grease  
Silt Depth: **0** (in.) Deposits Extent:  
Infiltration: **Weeper** Pipe Seal Cond: **Cracked**
